Draft Translation 624  
July 1977

# CONSTRUCTION OF FROZEN FILL DAMS IN ARCTIC COASTAL REGIONS

P.A. Grishin et al

LennorNIIProyekt developed plans for different designs of frozen dams for the Arctic coastal regions. Some of them have been built and are operating successfully, while others are not yet complete and are under observation. This article sets forth the results of observations, analysis of deviations from plans during the construction of installations and experience in their operation.

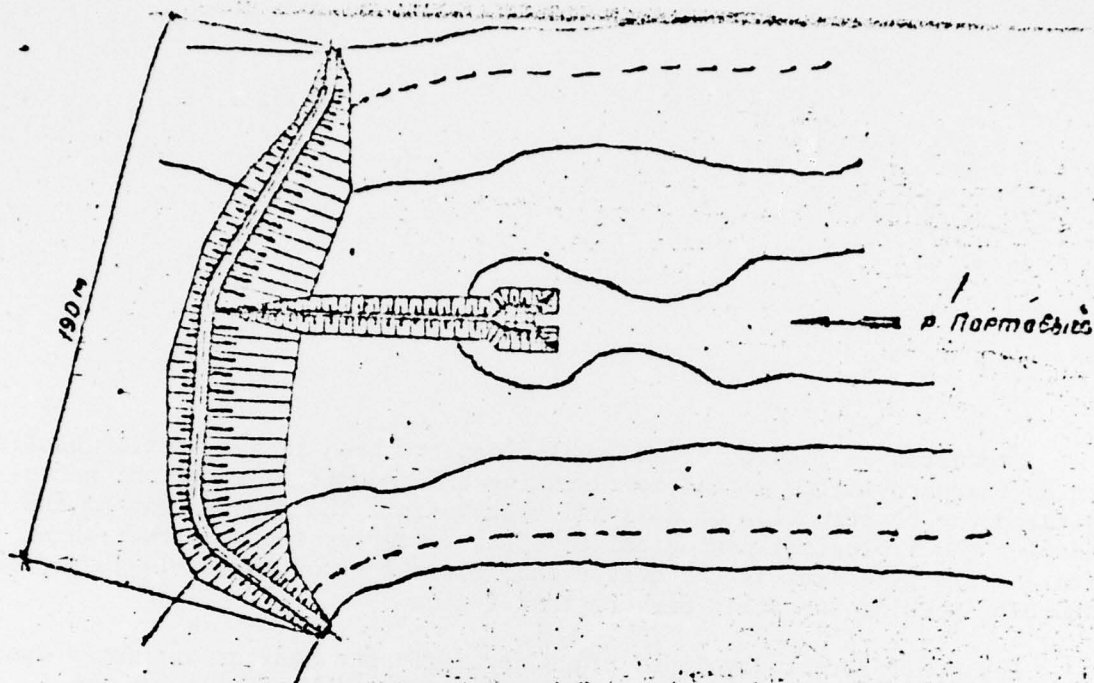
Figure 1. Plan of dam in western sector of Arctic.  
Key: 1, Porta[remainder illegible] River.

It was decided to erect a rock-earth-fill dam of the frozen type (Figures 1, 2). The upper wedge was filled with highly compacted loam and the density of the soil skeleton was  $1.6 \text{ t/m}^3$ . The lower wedge was filled with stones 30 cm in diameter.

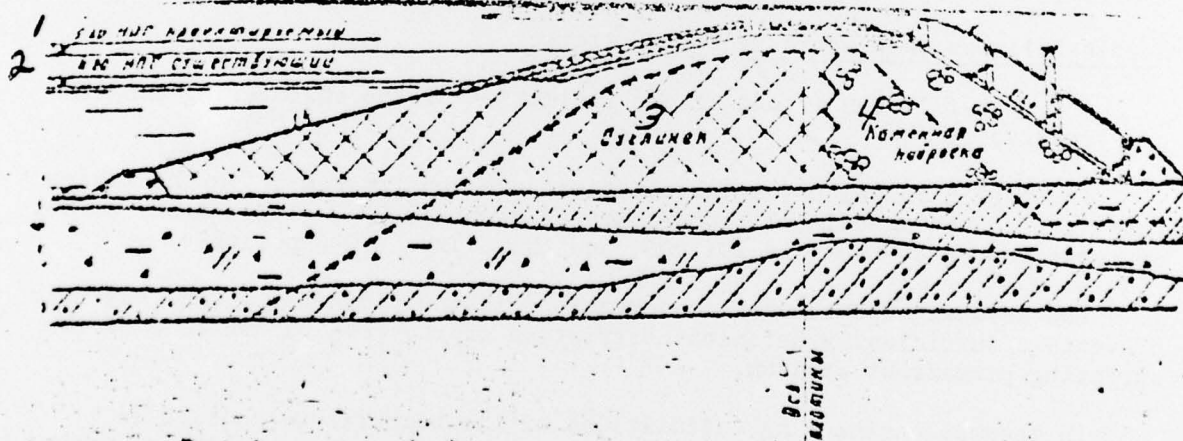
Figure 2. Cross section of frozen-fill dam in western sector of Arctic.  
Key: 1, [Several words or letters illegible] planned; 2, [Several words or letters illegible] existing; 3, Loamy clay; 4, Rock fill; 5, Axis of dam.
